ORNL/TM-2019/1071  
CRADA/NFE-17-06791

# Repairing polycrystalline Inconel 100 using additive manufacturing

**CRADA FINAL REPORT**  
**NFE-17-06791**

**REPAIRING POLYCRYSTALLINE IN 100 USING LASER BLOWN  
POWDER ADDITIVE MANUFACTURING**

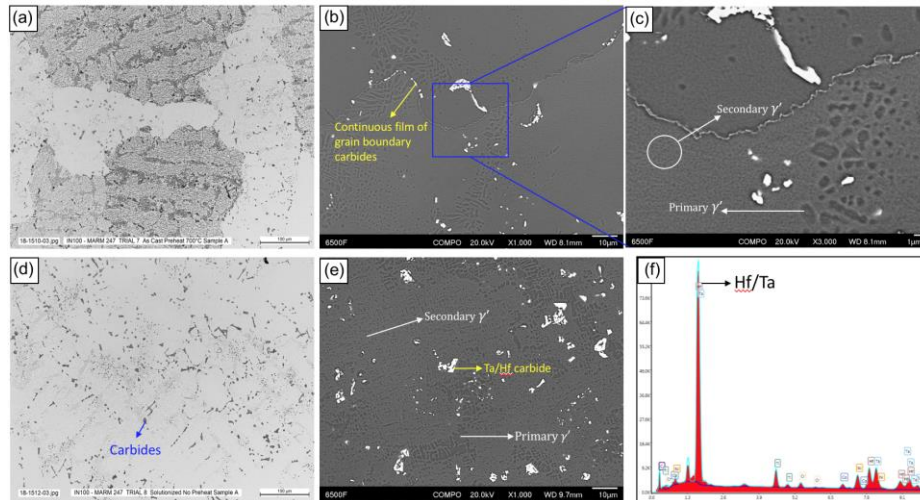
**Figure 1: Microstructure of the substrate (a)-(c) in the as received condition showing the presence of  $\gamma'$  and Hf/Ta rich grain boundary carbides (d)-(f) in the solution annealed condition showing that the treatment dissolved the grain boundary carbides and also modified the  $\gamma'$  morphology**

The substrate was characterized using optical microscopy and scanning electron microscopy. Samples were mounted and polished using regular metallographic methods and etched using Kallings reagent to reveal the microstructure. Results are shown in figure 1. Figure 1 (a)-(c) show the optical and SEM micrographs of the substrate samples in the as received conditions. The microstructure clearly shows a bi modal distribution of  $\gamma'$  with Hf/Ta rich carbides along the grain boundaries. Such continuous network of carbides acts as potential sites for liquation cracking during repair. Therefore to eliminate the carbides and coarsen the  $\gamma'$  a subsolvus solution annealing treatment was given to the substrates. The as received coupons were solution annealed at 1093°C for 2 hours in a vacuum furnace. The solution annealing treatment was a sub solvus treatment. The solution annealed substrates are also shown in figure 1(d)-(f). Solution annealing led to the dissolution of the continuous network of carbides along the grain boundary. While the grain boundary carbides dissolved, energy-dispersive spectroscopy (EDS) showed that the actual composition of the carbides did not change. In addition the procedure coarsened the secondary  $\gamma'$  precipitates, and caused the dissolution of the continuous network of grain boundary carbides.

Previous reports have shown that solution annealing the substrates before repairing resulted in improved resistance to cracking. Figure 1 clearly shows that solution annealing plates eliminated the continuous grain boundary carbides and also coarsened the fine secondary  $\gamma'$  precipitates in the as received material. The post deposit optical micrographs are shown in figure 6.

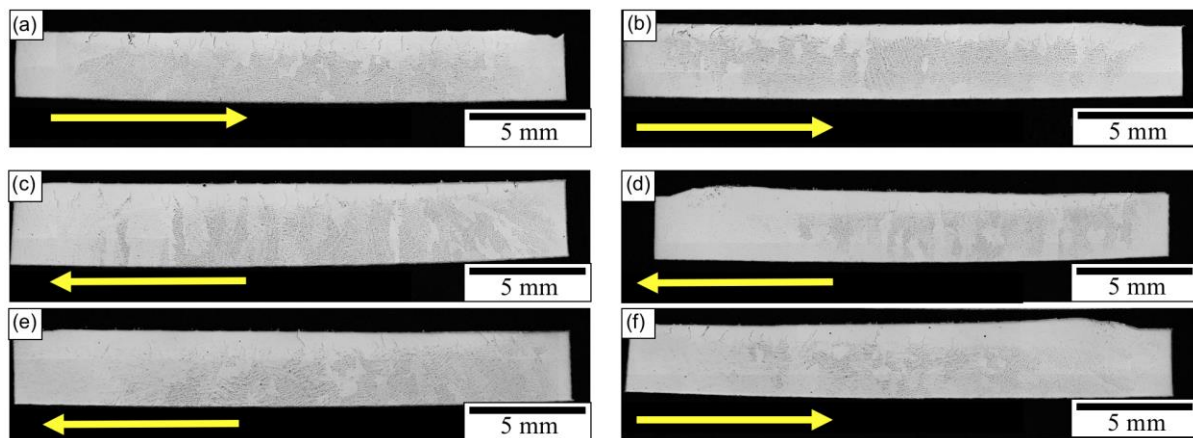
**Figure 2: Micrographs of the coupons on which the deposits were fabricated. The arrow indicates the direction of laser travel where the head points towards the end of the build. Samples (a)-(f) correspond to samples fabricated using trial-1 thru' 6. Note that the samples fabricated with a tighter hatch spacing and lower speeds reduced the cracking tendency.**

The results of the deposition trials are shown in figure 2. Figure 2 shows that the best results were obtained for deposits fabricated using a tighter hatch spacing. In addition, figure 3 shows the deposit substrate interface at higher magnification. The micrographs clearly shows that most of the cracking occurred at the heat affected zone. The cracks then propagated to the deposited material.

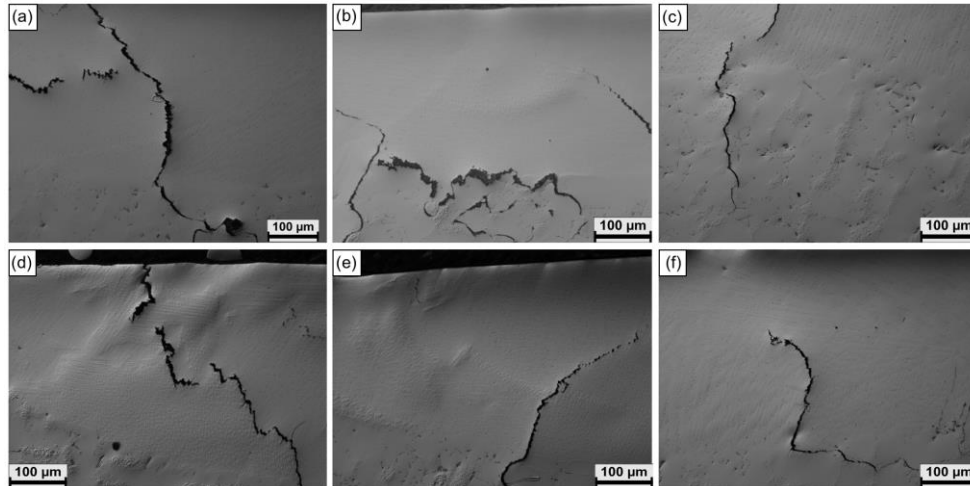
**Figure 3: Micrographs showing the cracking at the heat affected zone and the substrate. (a)-(f) corresponding to the various trials**

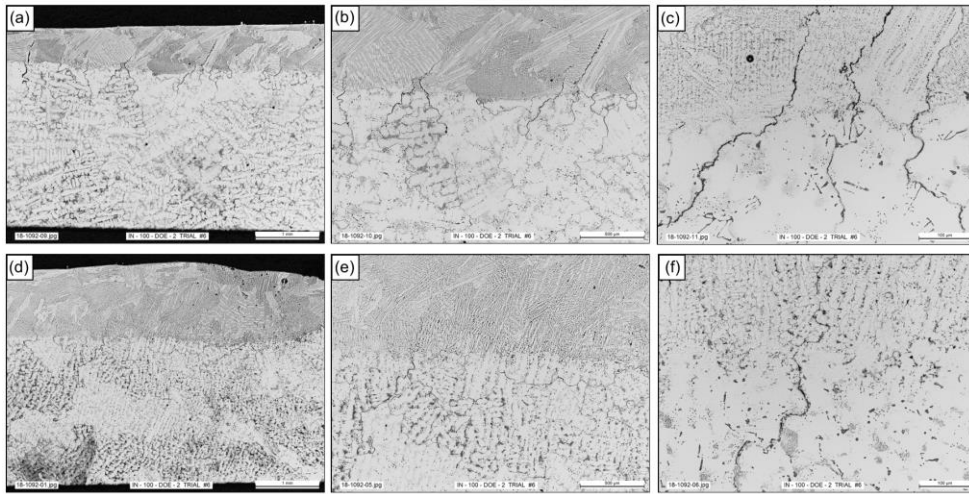
**Figure 4: Micrographs (a)-(c) showing the presence of cracking in the beginning of the deposit only at the start of the build (d)-(f) showing the presence of cracking at the heat affected zone at the end of the deposit. Note that this section does not have any cracks in the deposits.**

Figures 4 and 5 show the interface structure of the deposits fabricated on the as cast substrate. The optical micrograph clearly shows that the cracking predominantly occurs in the heat affected zone. This mechanism of cracking could be attributed to heat affected zone liquation cracking. To conduct a more detailed investigation of the cracking mechanism detailed Scanning Electron Microscopy (SEM) microscopy was performed. The SEM microscopy clearly shows the presence of liquid films along the carbides. This mechanism is well known and has been documented in the existing literature [7]. The carbides were identified to be rich in Hf and Ti, as shown in the EDS spot analysis. Note that the cracks initiate in the heat affected zone and propagate into the deposit. However the cracking in the

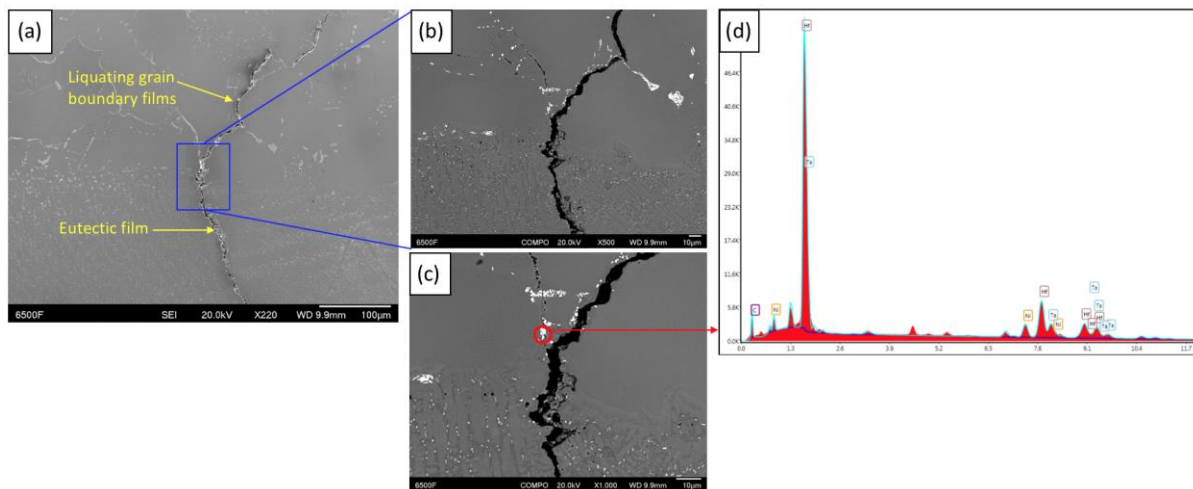
**Figure 5: Micrographs showing the cracking at the heat affected zone and in the substrate (a) Secondary electron image at low magnification showing the presence of liquid films indicating some form of hot cracking (b)-(c) higher magnification Back Scatter Electron (BSE) micrographs showing melting of carbides near the crack. EDS showing the presence of Hf/Ta rich carbides liquation.**

deposit is attributed to solidification cracking, which is evident from the formation of eutectic films at the interface [4], [5]. In addition to this characterization of the as deposited structure shows the presence of carbides in the interdendritic region due to the  $L \rightarrow MC$  (Hf/Ta) +  $\gamma$  eutectic reaction during the solidification. However, no evidence was observed for the constitutive liquation in the deposit. Nearly all the cracks in the deposit were solidification cracks.

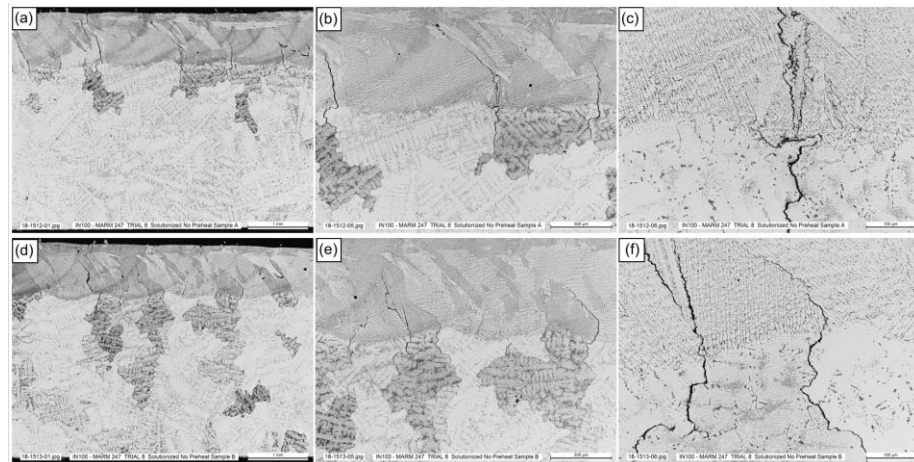
**Figure 6: Deposits fabricated in solution annealed plates. The while the total number of micro cracks are reduced the samples did show cracking in the heat affected zone of the substrate as shown in the micrographs (a)-(f)**

The deposits indicate that the cracking tendency is lower in the solutionized samples in comparison to the as received samples. This can be attributed to the elimination of grain boundary carbides and coarsening of  $\gamma'$  eutectic as a result of the solution annealing treatment. Detailed SEM investigations were performed to identify the cracking mechanisms. The micrographs are shown in figure 7 (a)-(c). The SEM micrographs show that similar cracking mechanisms operate despite the solution annealing treatments being performed. The heat affected zone cracking persists and occurs adjacent to the carbide phases which liquate as shown in figure 7(c). In this case as well the cracks in the IN 100 deposits were predominantly attributed to solidification cracking as shown in figure 7(b). While solution annealing reduced the cracking susceptibility in the builds, it was not possible for solution annealing to completely eliminate cracking in the deposits.

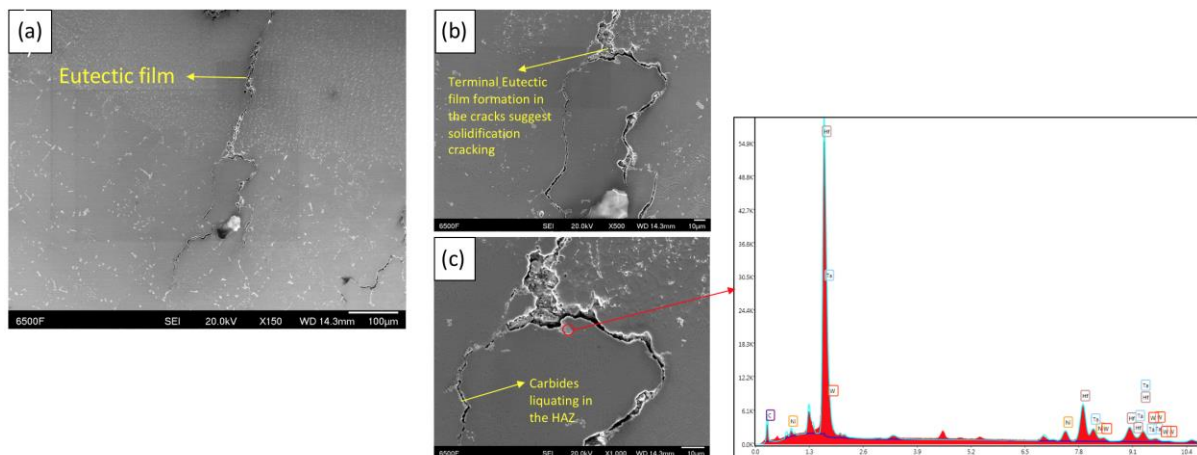
**Figure 7: SEM micrographs of the cracked section. The cracks clearly show the presence of liquid film in the deposit shown at a higher magnification in (b) and in the substrate at a higher magnification (c). Even**

**in the solution annealed substrates cracking occurred beside carbides suggesting liquation cracking**

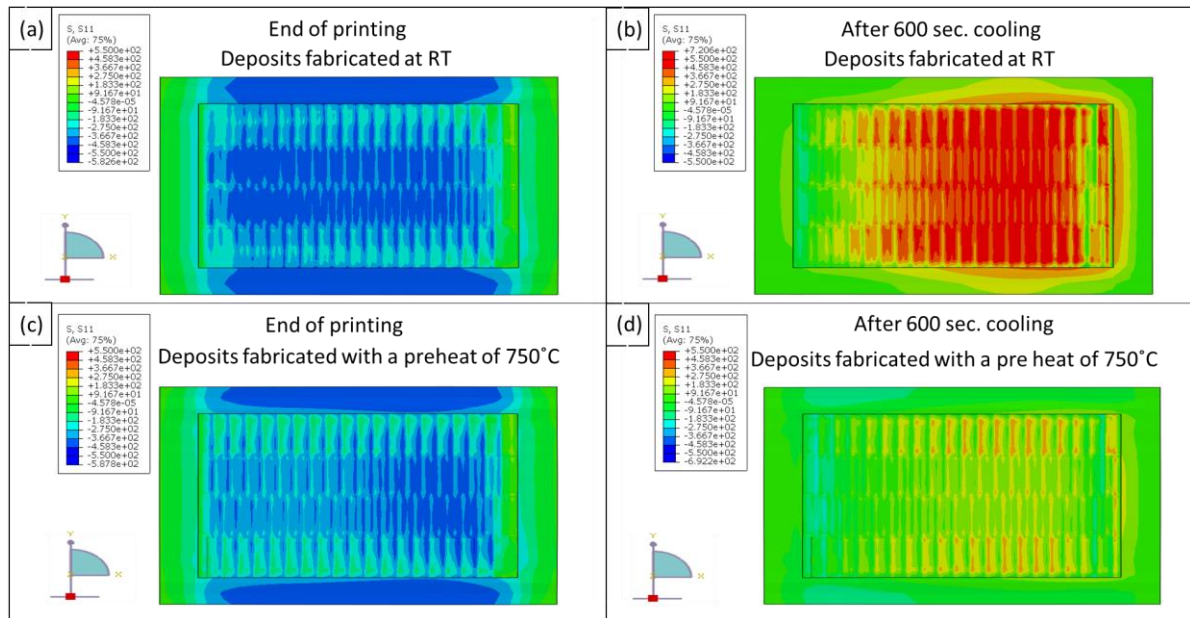
**Figure 8: Thermal-mechanical simulations of deposits fabricated at room temperature (a) & (b) and of deposits fabricated with a pre heat of 750°C (c) & (d). The stress comparison of RT (b) to preheat (d) show that 750°C preheat on the deposit significantly reduces the residual stress arising during cooling.**

It has been reported that preheating the substrate leads to a reduction in the cracking tendency primarily by relieving the strains [9]. Therefore to identify the ideal pre heat temperature where the net tensile strain in the build during solidification is low, modeling was performed. The results are presented below in figure 8.

Figure 8(a) and (b) shows the stress development in the deposit when fabricated on coupons at room temperature. Note the significant tensile residual stress in the deposit and the

substrate in Fig.8(b). However, when the preheat on the substrate is increased to 750°C, the deposit displays an overwhelmingly less residual stress during cooling in Fig.8(d). Therefore, preheating more than 750°C and cooling slowly may have led to mitigation or elimination of cracks. Based on these results attempts to fabricate deposits with a pre heat temperature of 750°C was made by integrating an industrial hot plate inside the build chamber of laser deposition machine. The micrographs of the pre-heated deposits are shown in figure 9.

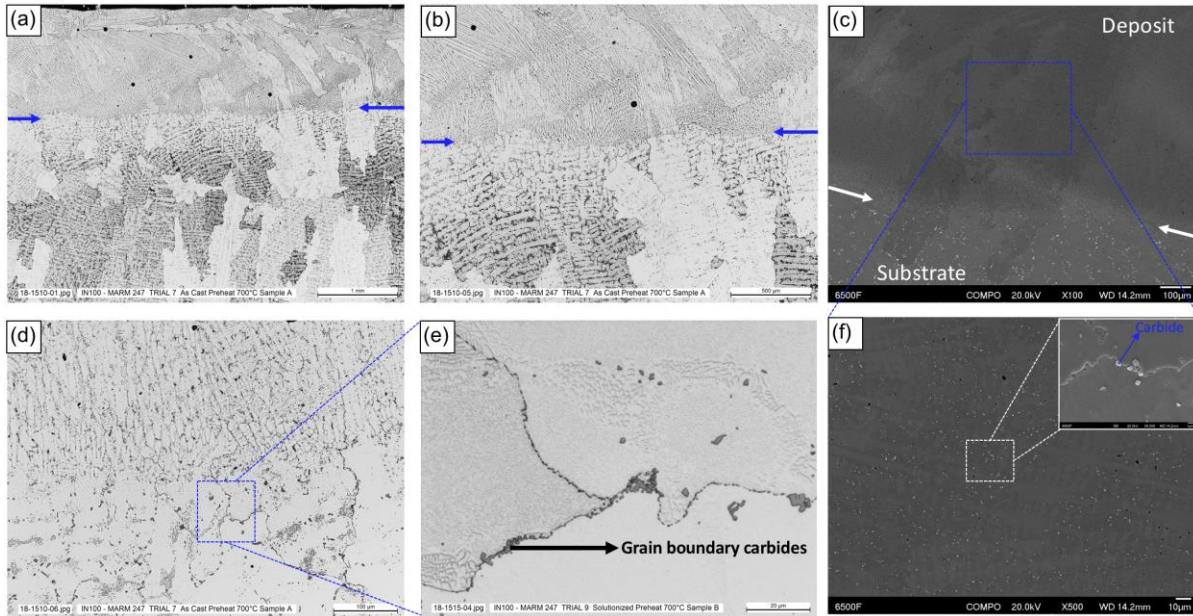
**Figure 9: Micrographs showing the absence of liquation cracking and solidification cracking in the deposits fabricated with a preheat of 750°C. Note the absence of cracks despite the continuous network of grain boundary carbides in the heat affected zone**

Figures 9(a)&(b) show the deposit substrate interface without any cracks. Figure 9(c)-(e) show the same interface at higher magnification showing that despite the presence of significant grain boundary carbide phases similar to the as received material, cracking did not occur. This would have been due to the shallower thermal gradients experienced by the material, which could have suppressed the liquation of these grain boundary carbide phases. Figure 9(f) shows the micrograph of the deposit. No  $\gamma'$  was observed in the deposit, however the inset shows the deposit at higher magnification showing the presence of carbides present in the interdendritic region. Based on the extent of characterization performed within phase 1 it is clear that the deposit fabricated by pre heating the substrate did not show any major difference with those fabricated without any preheat. However the role of strain age cracking during post weld heat treatment of the deposits were not evaluated. This will be performed in phase 2 of this work.
